**OLDER BRIDGES
LIKE US
STILL PRODUCTIVE**

JOSEPH J. PULLARO, P.E.
ACTIVITIES UNLIMITED
FEBRUARY 25, 2025

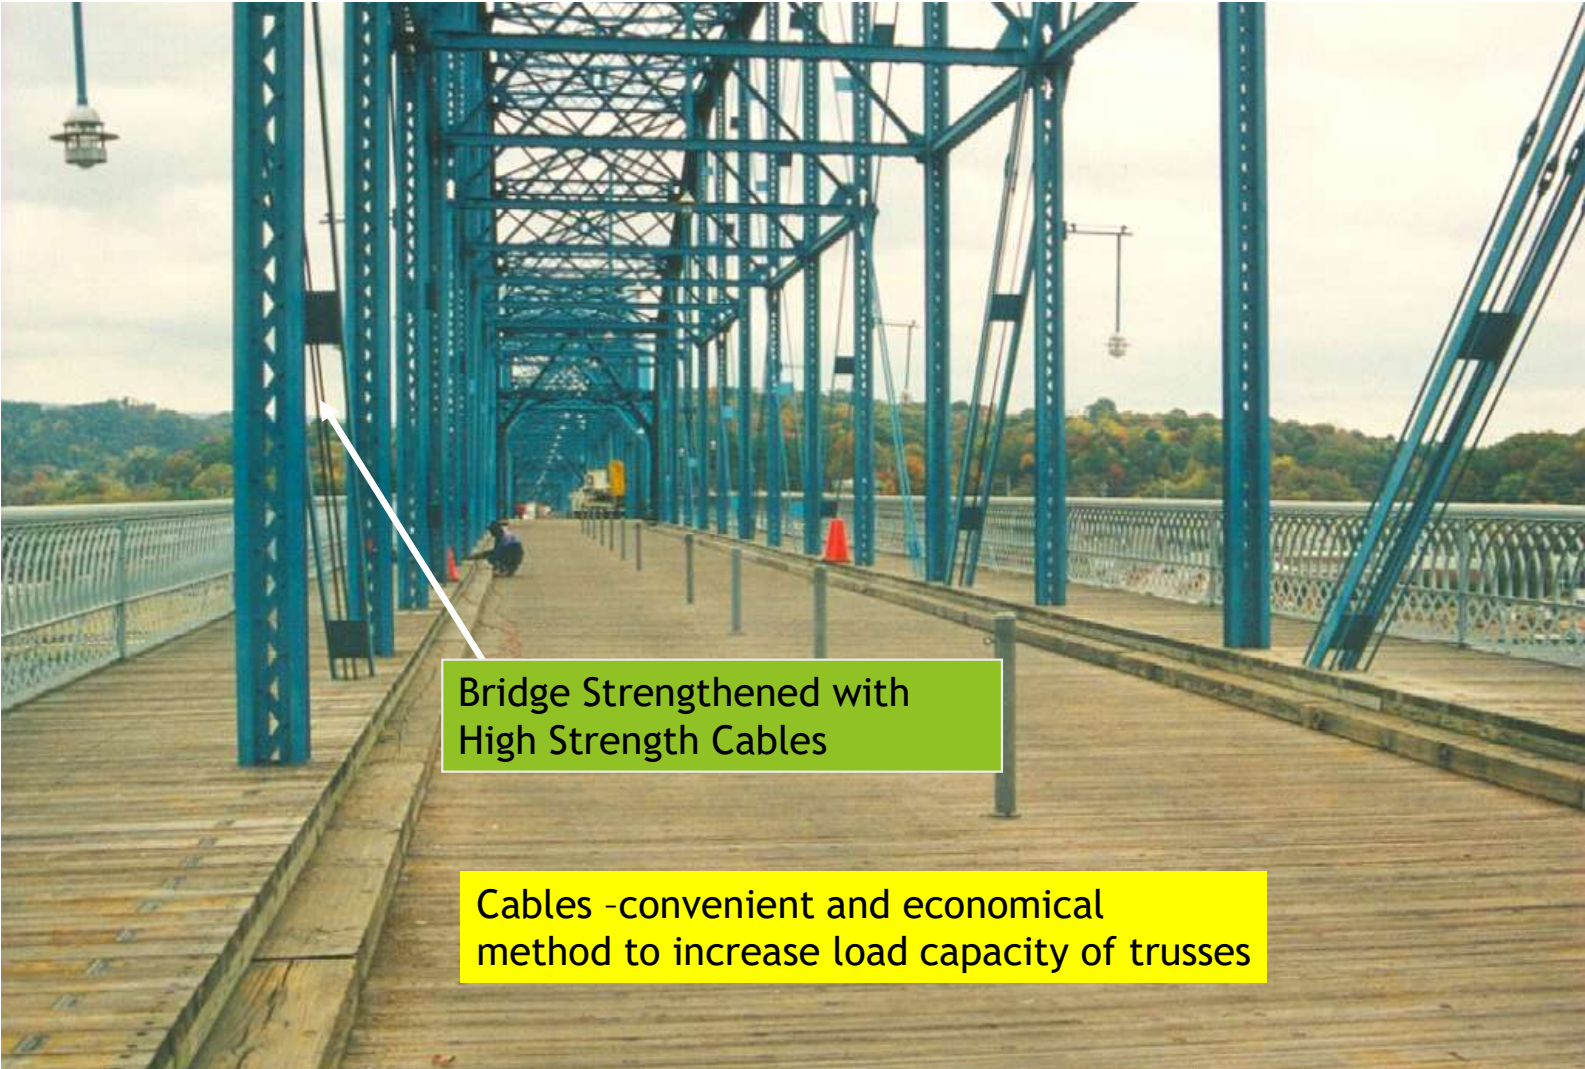
Tensioning cables removes load from eye bars

Bridge Strengthened with High Strength Cables

Cables -convenient and economical method to increase load capacity of trusses

- 0.6" Diameter
- GR270 Coated Strands

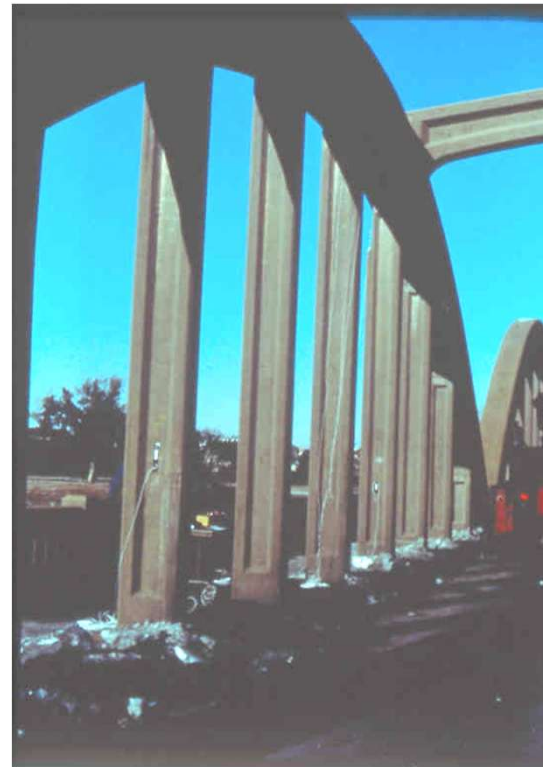
PROBLEMS

- ▶ CRACKED VERTICALS

- ▶ LOAD TESTING
- ▶ 3D ANALYSIS
- ▶ MEMBER STRESSES LOW

NEED TO REINFORCE VERTICALS

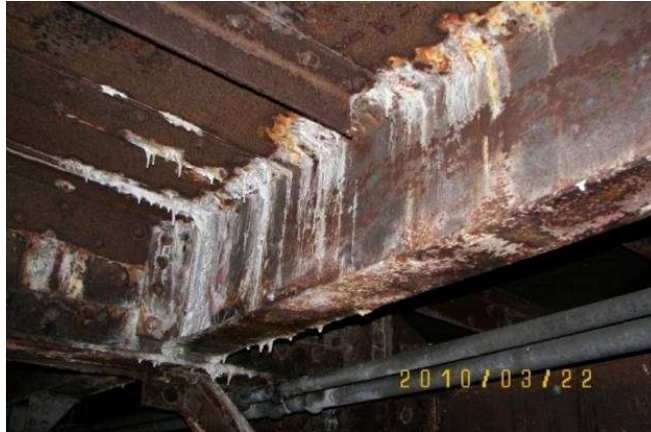
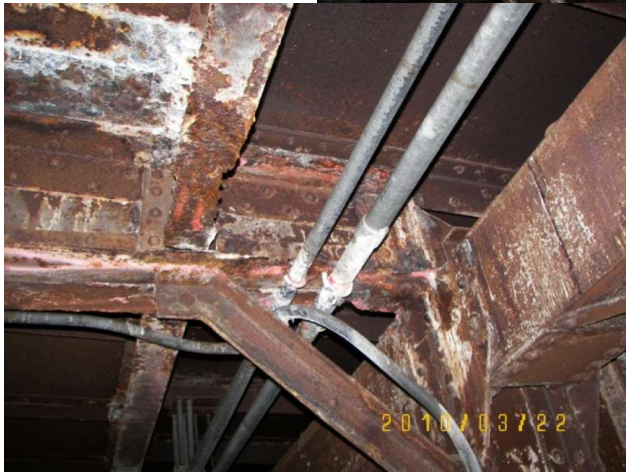
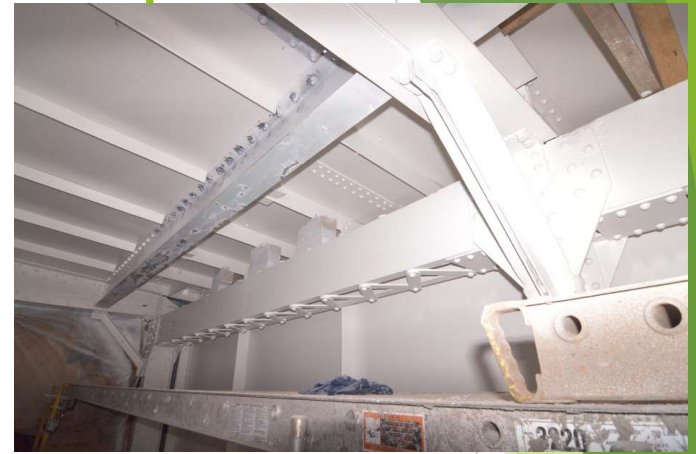
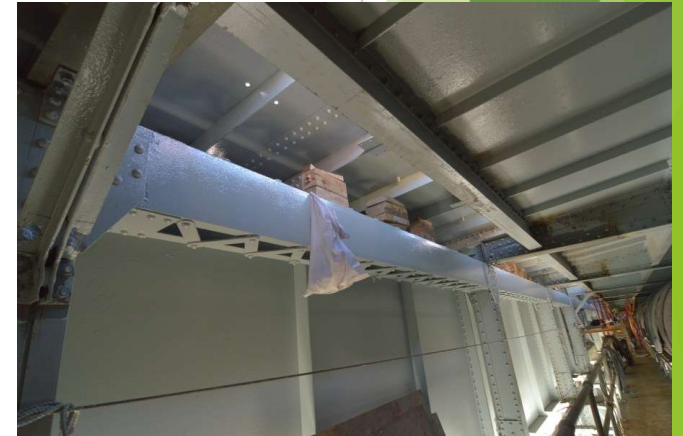
Structural Rehabilitation - Steel Repairs

- STEEL FLOORBEAM SPLICE REPAIR
- STEEL STRINGER REPLACEMENT

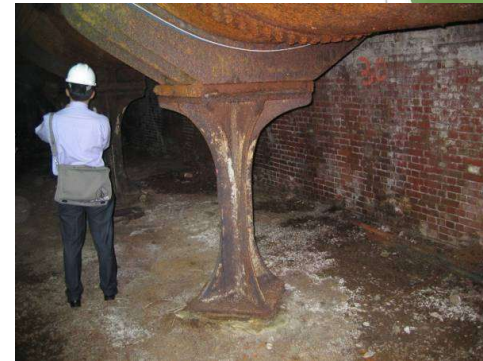
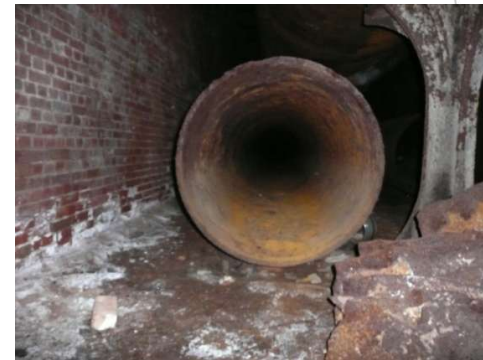
Existing Conditions - Croton Aqueduct Pipe

**TYPICAL WROUGHT IRON PIPE AND CAST IRON
PEDESTAL WITH SADDLE - MASONRY ATTIC**

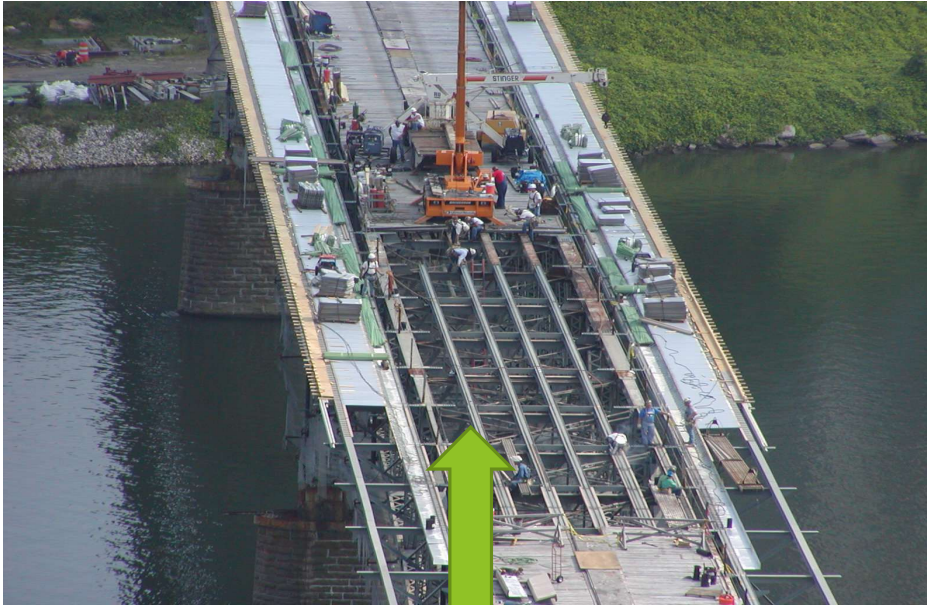
STRINGERS, REDUNDANT, MORE THAN 3

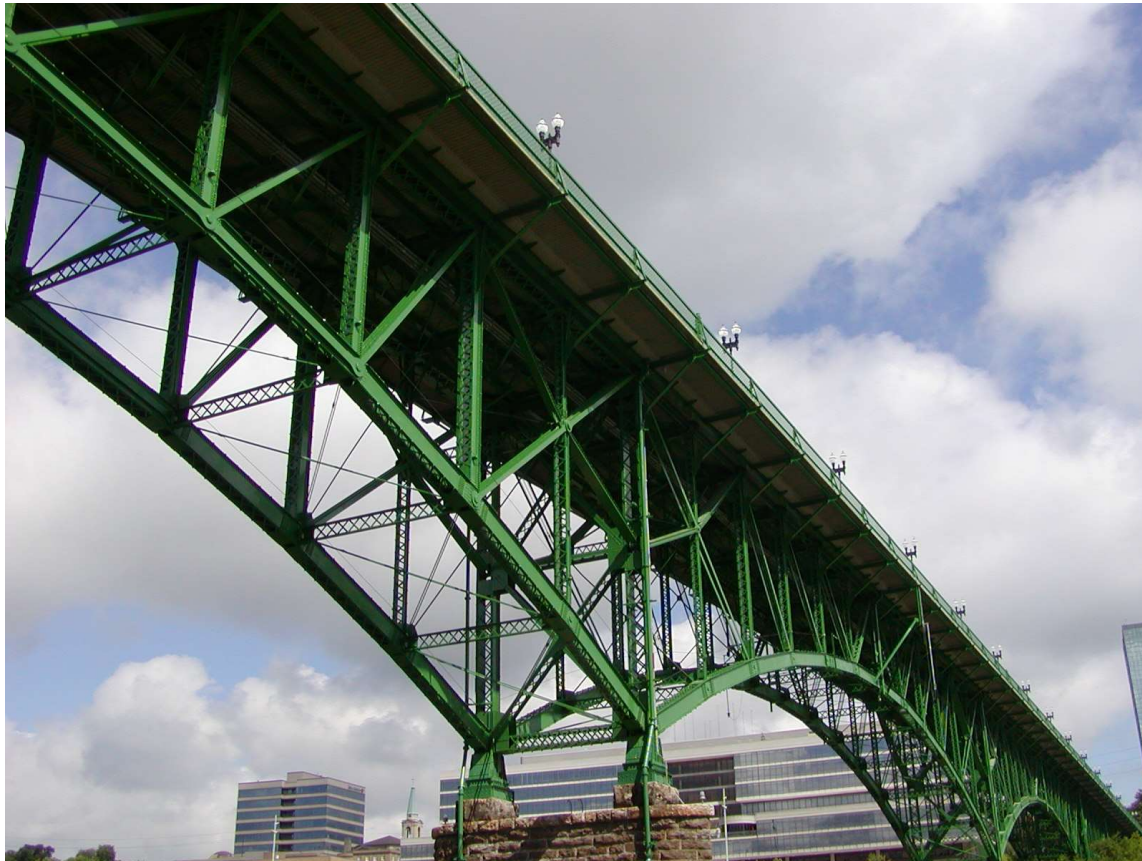
TRUSSES- FRACTURE CRITICAL-NON REDUNDANT

FAILURE OF ONE MEMBER MAY LEAD TO TOTAL COLLAPSE

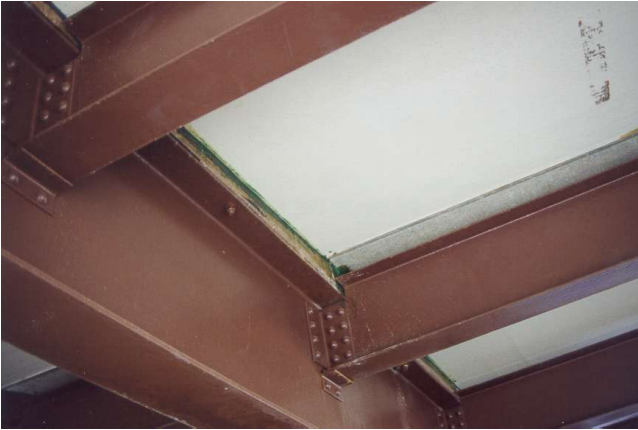
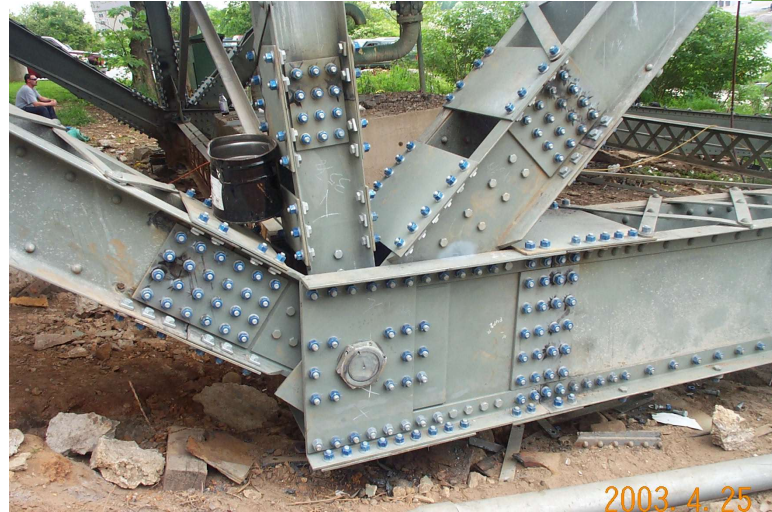
RIVETS AND BOLTS GOOD FOR FATIGUE

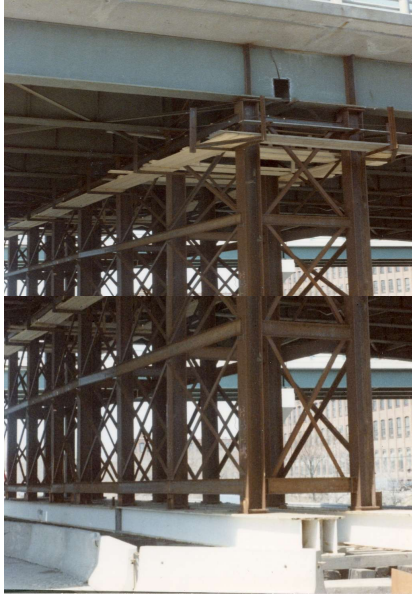
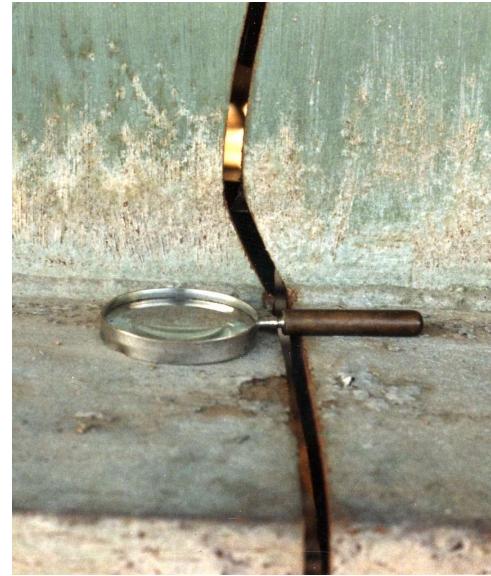
WELDING NOT GOOD FOR FATIGUE/FRACTURE

IMPROPER DETAILS LEADS TO HIGH CONSTRAINTS

WELDING INTRODUCES SMALL DEFECTS IN METAL

WITH ENOUGH CYCLES, SMALL CRACKS GROW UNTIL THEY BECOME CRITICAL

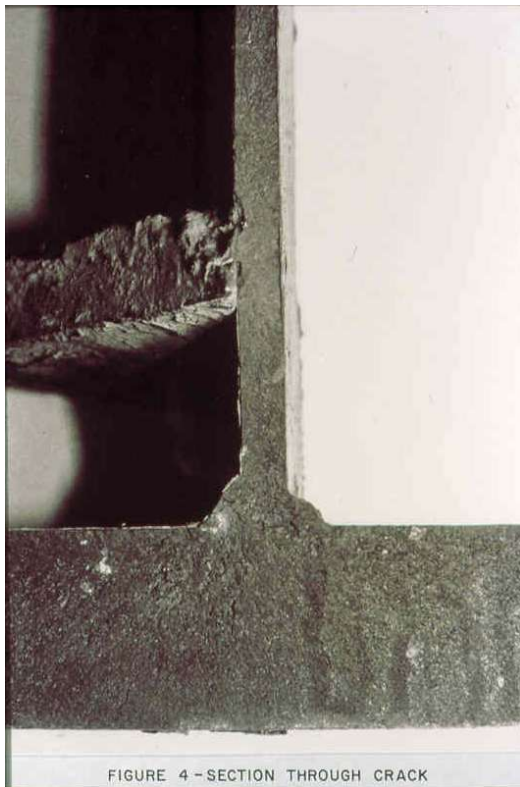
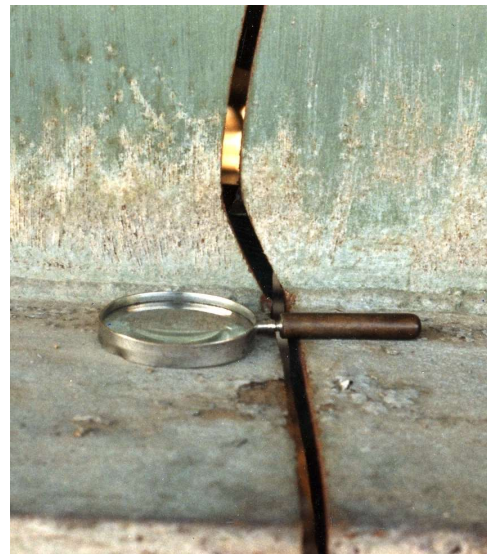
THE FIX- SOFTEN DETAIL IN AREAS OF TENSION

(D-3) & (D-3) DIAPHRAGM SOFTENING
NTS

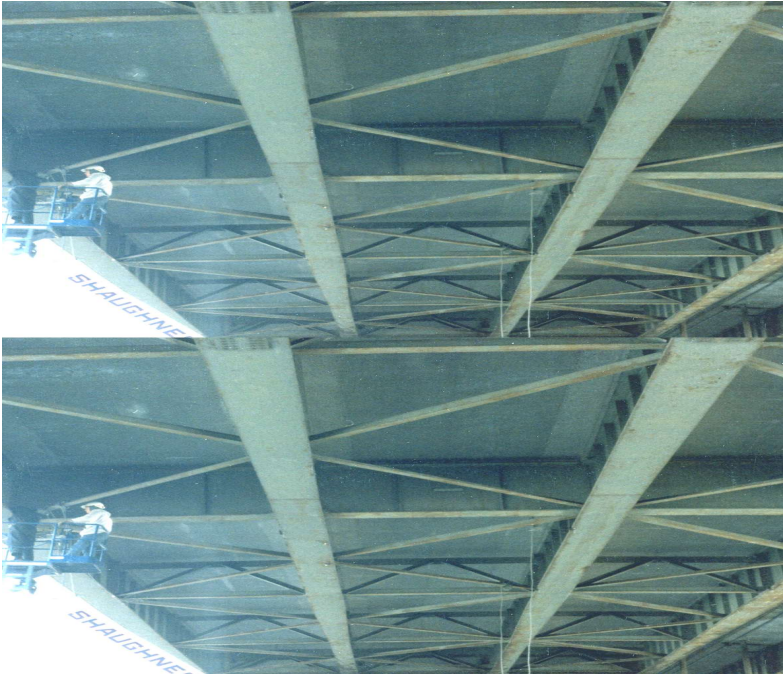
POOR DETAIL-WELDED CONSTRAINT IN TENSION ZONE

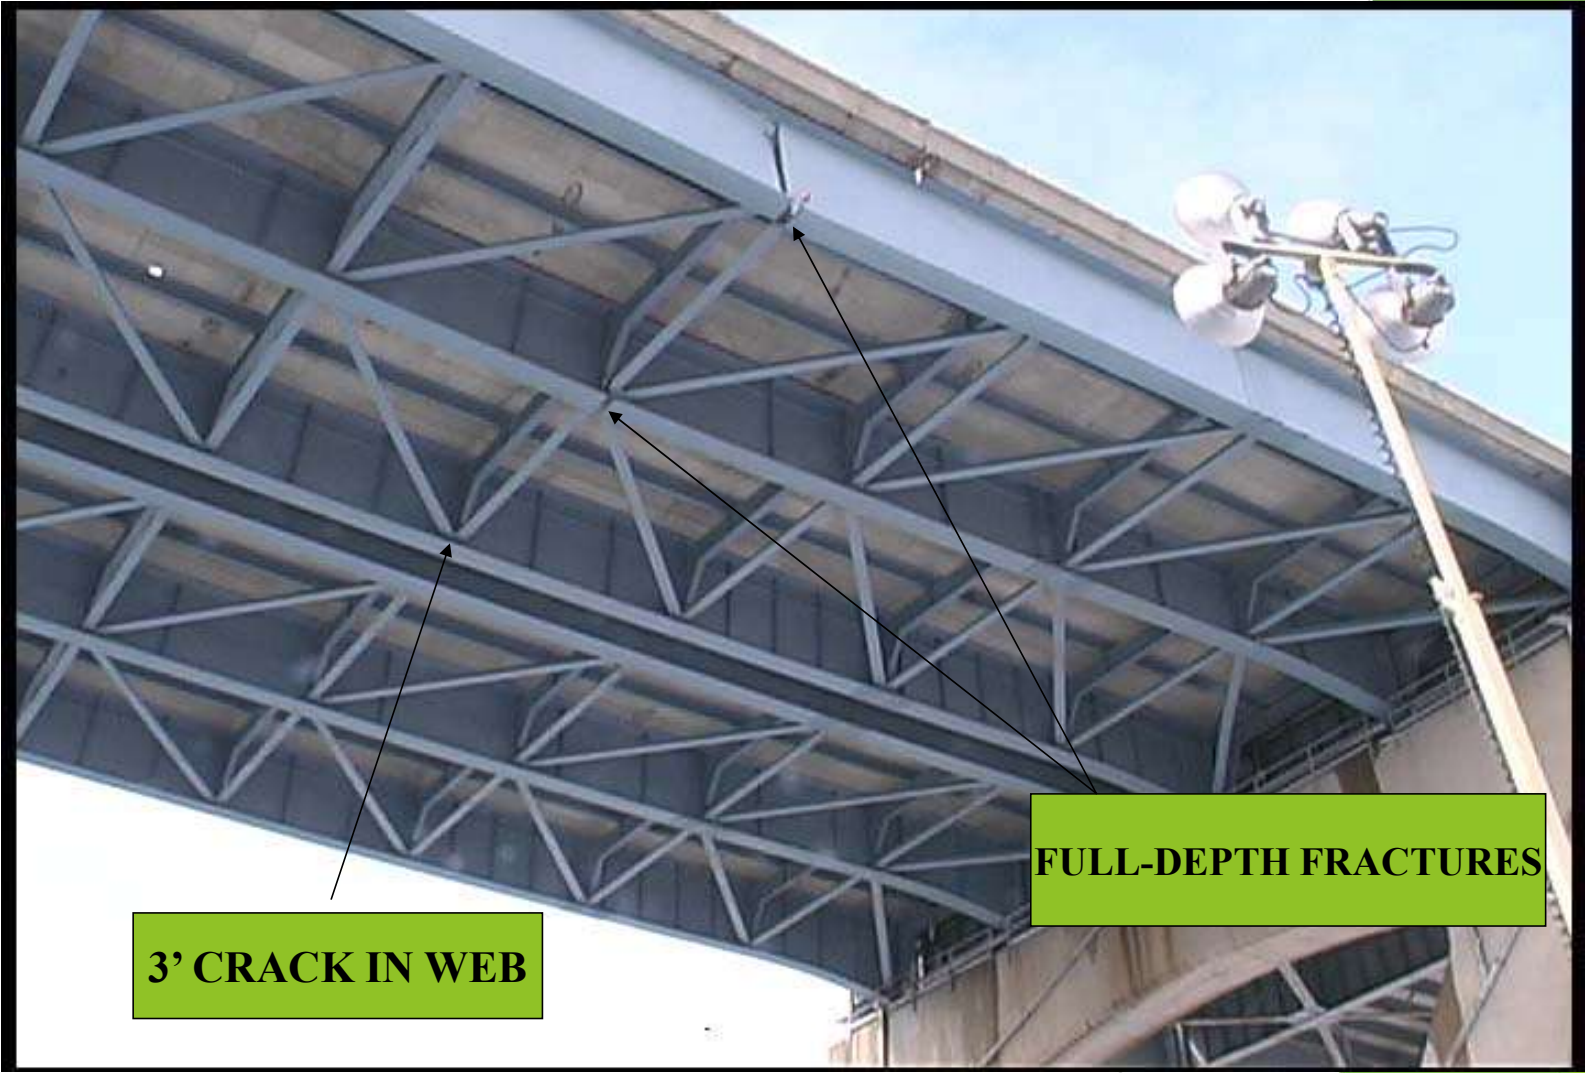
3' CRACK IN WEB

FULL-DEPTH FRACTURES

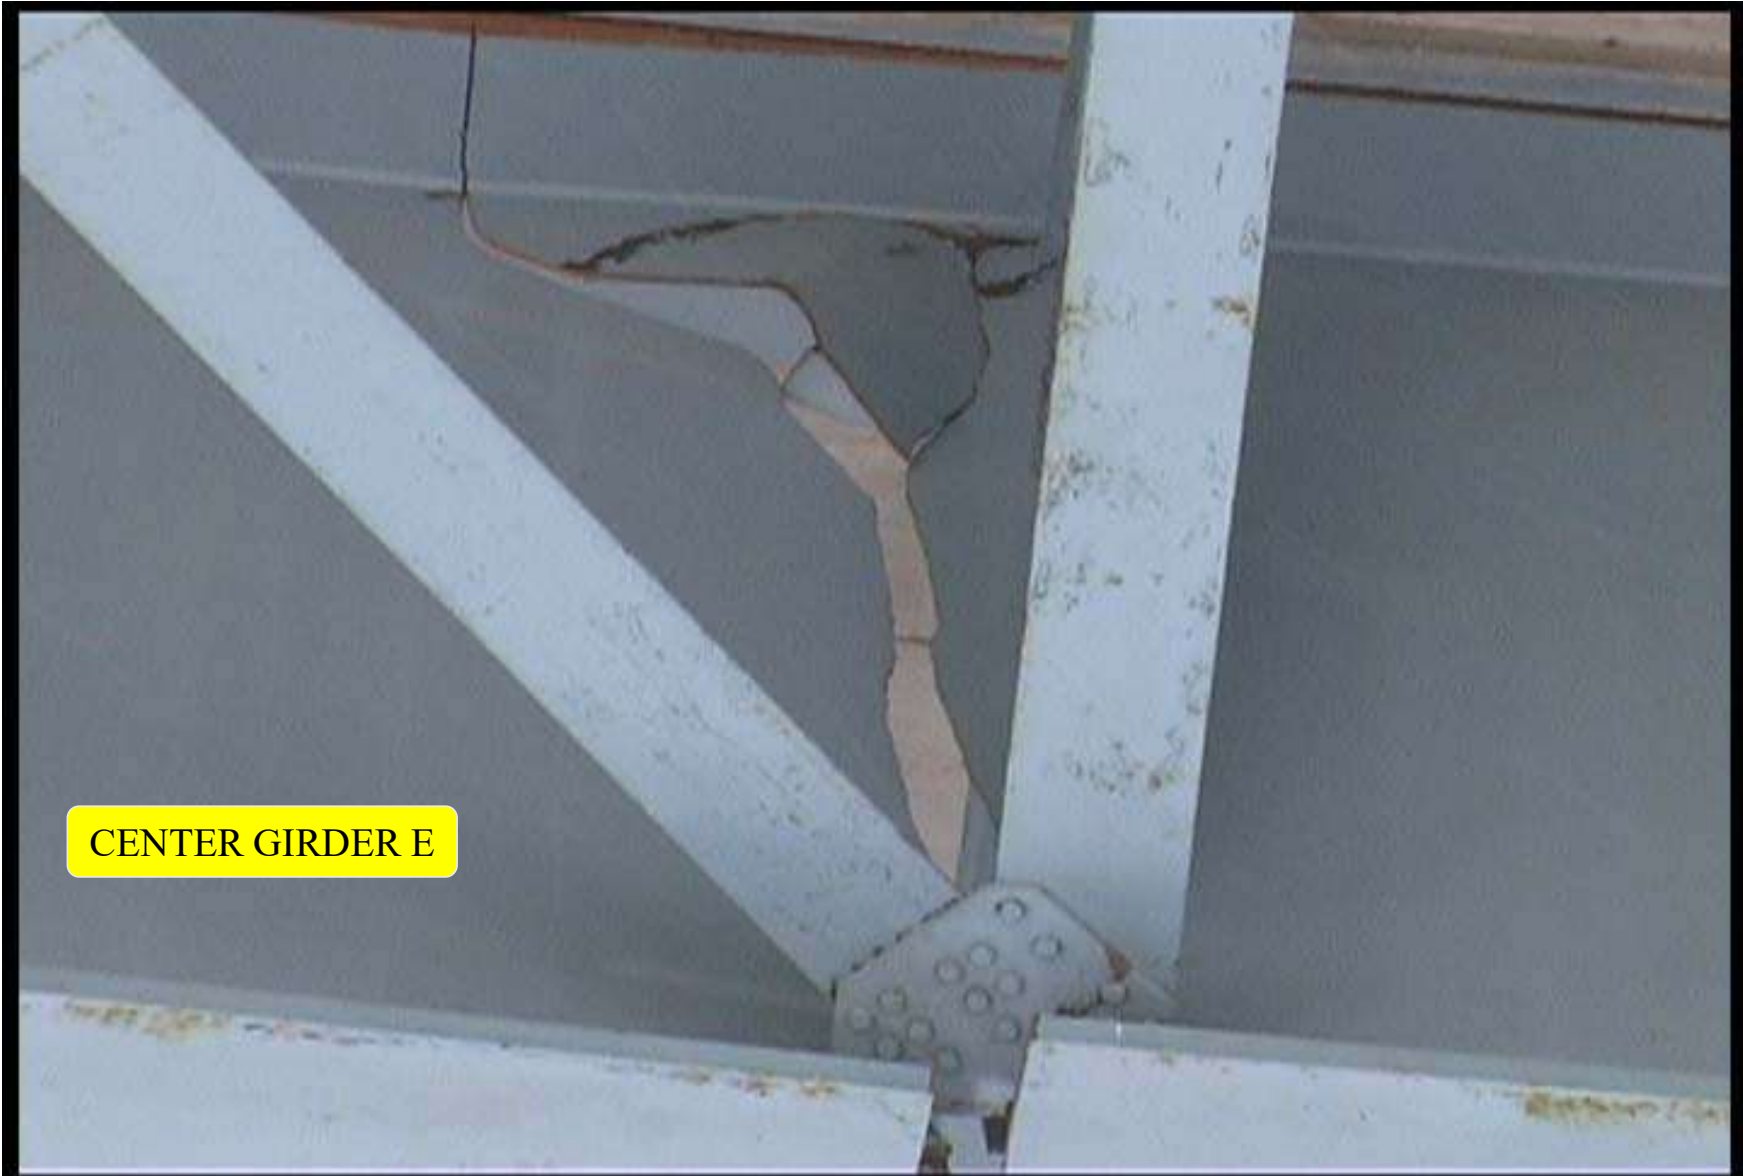
CENTER GIRDER E

Forces on the lateral bracing system increased the stress concentration in the web gap by about 38%.
